Moving a Three-Span Truss Bridge*

By C. E. Smith

SYNOPSIS—The shifting of the Missouri Pacific Ry. bridge over the Kaw River at Kansas City was a noteworthy piece of work necessitated by the disastrous flood of 1903. To adjust the bridge to the new channel its three truss spans of 180 ft. were first raised about 9 ft. above their original elevation. Then the three spans, as one 540-ft. structure, were swung laterally to the new alignment by a radial motion giving a shift of about 3 ft. at one end 26 ft. at the other end. Finally, that three spans (connected to form one structure) were moved about 123 ft. longitudinally to seat them on the new piers. All this involved very delicate work and very careful planning, especially as the bridge had to be kept open for traffic. The foundation work for the new substructure was complicated by the presence of a tangled

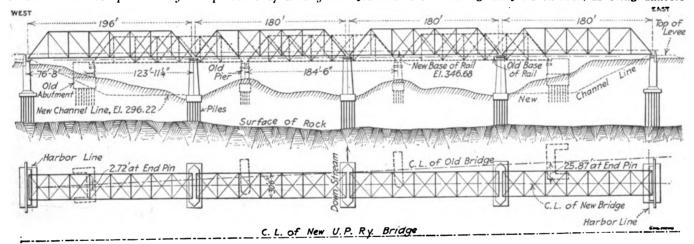
Fig. 1. Plan and Elevation of the Kaw River Bridge of the Missouri Pacific Ry. at Kansas City, Kan.

(Showing the old and new substructures and the old and new positions of the superstructure.)

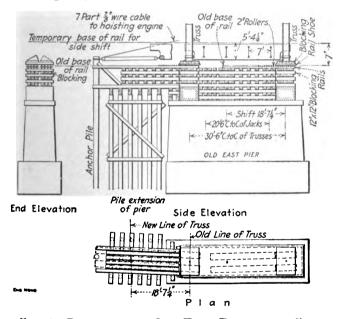
Fig. 4. Blocking on Old East Pier, with Side Extension of Pier to Carry the Bridge when Shifted Laterally

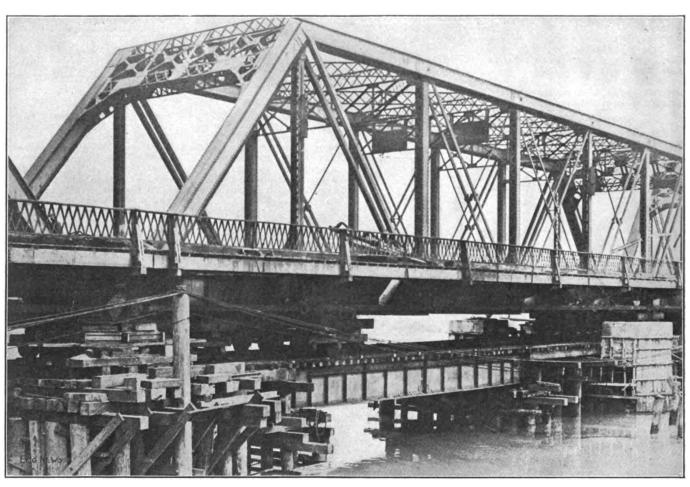
FIG. 10. THE SPANS RAISED AND SUPPORTED ON TRUCKS READY FOR LONGITUDINAL MOVEMENT
