A Rehabilitation Story

2009 - 2012

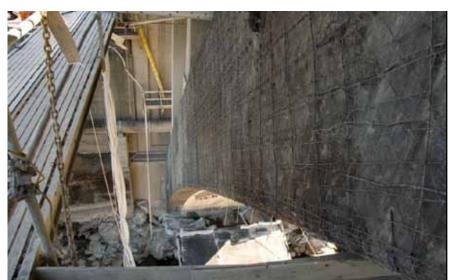
▼ Steel condition after Gunite removal

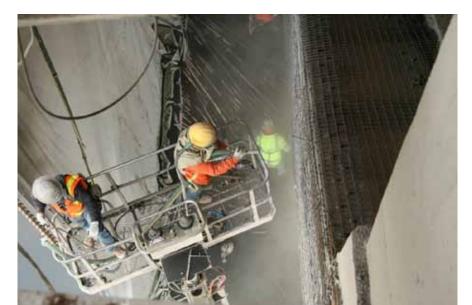
▲ Sandblasting the steel to achieve required surface finish

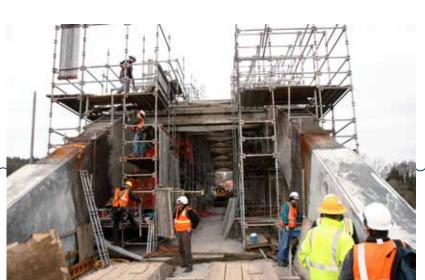
The final shotcrete coating

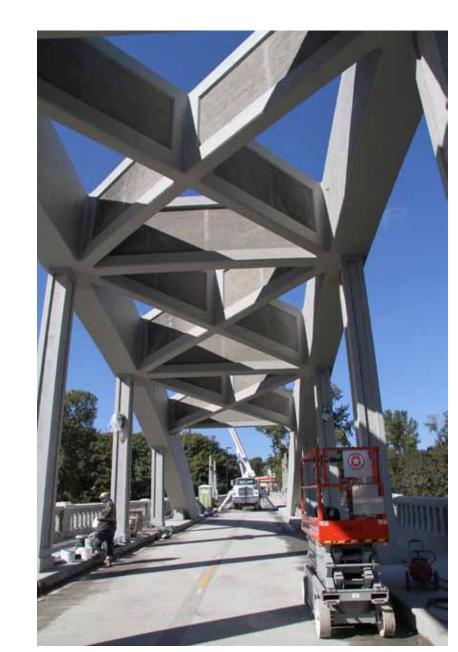
Concrete around the steel hangers was removed, damaged sections were plated and a new concrete encasement cast.

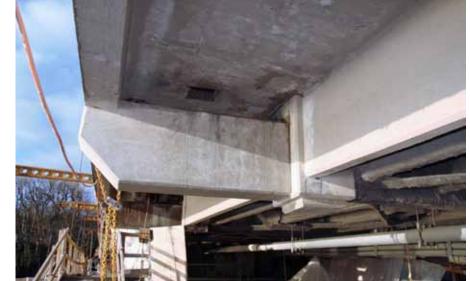
Damaged floor beam extensions supporting the sidewalks were recast in new concrete.

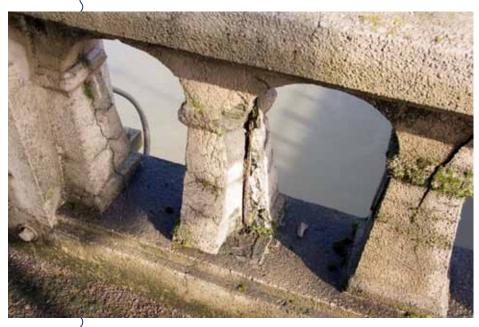
Saw cutting the base of the rail and removal of old sections with a backhoe

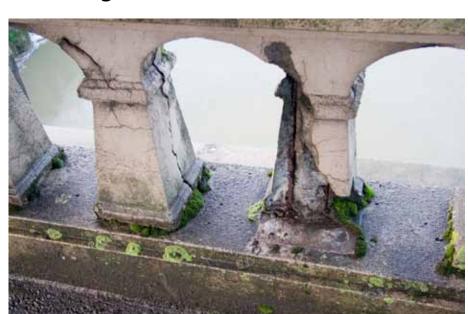
The replacement railing system is a replica of the original rail but designed to current safety standards. It is approved by Oregon's **State Historic Preservation** Office and is typically used on ODOT's historic bridge rehabilitation projects.

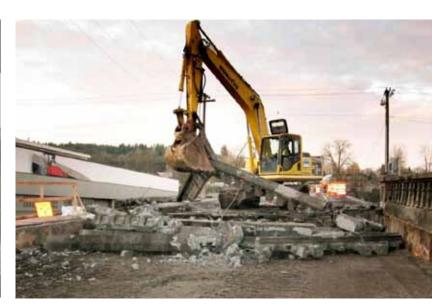
Sidewalks and rails were first removed \triangle

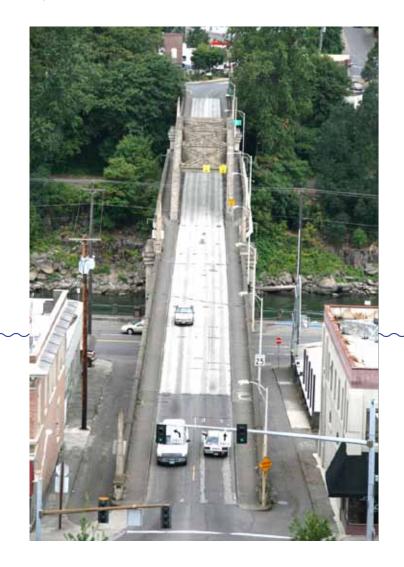
Access was a Challenge -----

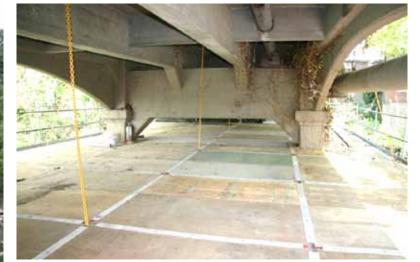
Barges were used for work below the QuikDeck Scaffolding

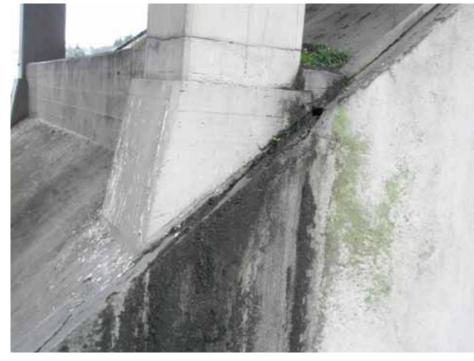
Before any major construction started, ODOT required the inspection and repair of all main span column connections to the arch ribs

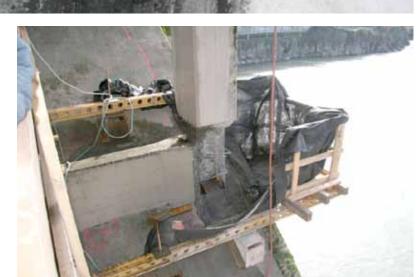
Main span column concrete base removal

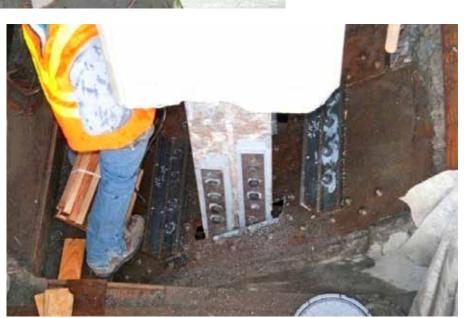
Bolted steel plates were used for the connection repairs

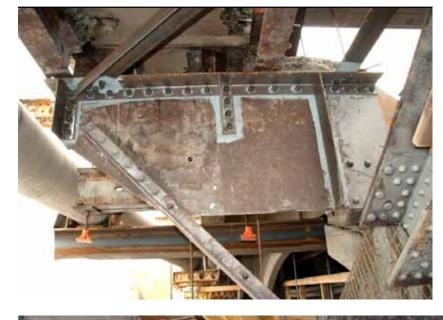
Corroded Components Needed Repairing or Replacing

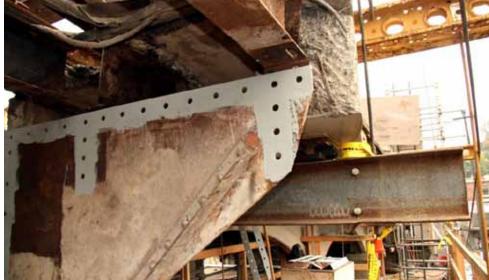
Eight stringers with excessive damage were replaced
