# Report [and Plans] also report on design of Quebec Bridge

# QUEBEC BRIDGE INQUIRY

## REPORT

The Royal Commission appointed by commission dated the thirty-first day of August, A.D. 1907, to inquire into the cause of the collapse of the Quebec bridge, begs to present its report as follows:—

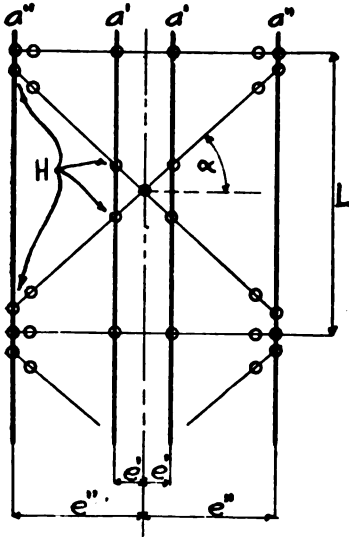
Fig. 21.

## LATTICING OF THE LOWER CHORD (L-9) OF THE QUEBEC BRIDGE.

The top latticing as sketched in Fig. 21 (the circles indicating rivets) will first be considered.

The latticing angles between the outer and inner web practically form a complete system, only insignificant bending on the ribs being caused by the centre lines of the diagonals not meeting at the centre line of the ribs. We can apply formula (8) on page 198, to find the area which would be required in these angles, assuming hinges at points *H*.
