BYERS PIPE

**GENUINE WROUGHT IRON
FULL WEIGHT GUARANTEED**

BULLETIN No. 26A
Superseding Bulletin No. 26

First Edition
JAN., 1922

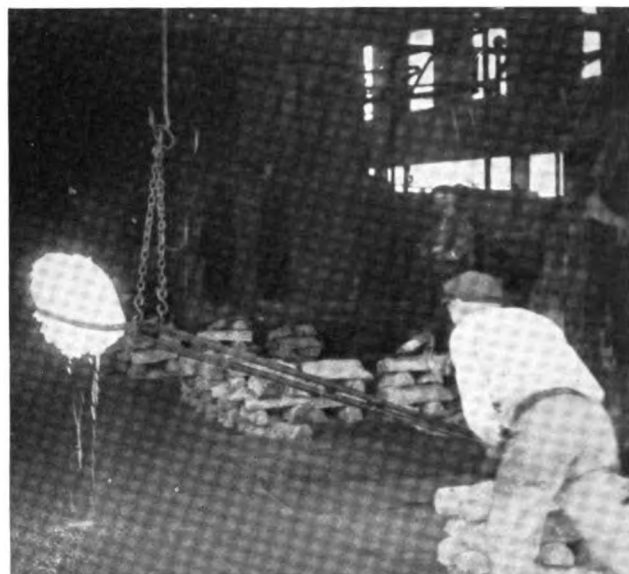
Fig. C

Ball of wrought iron in a pasty condition, as it is taken from the furnace. Being pasty (not fluid) before being taken from the furnace, segregation of impurities is precluded.

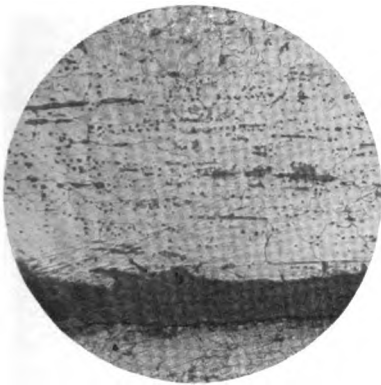
Nos. 26-A, B and C—Byers Pipe installed in water service in Weyman Building, Pittsburgh, Pa., in 1883. Removed in 1917, in very good condition. Rather banded structure, with good slag distribution in some zones, and deficient in others. Carbon traces. Heavy slag streak in No. 26-A objectionable.

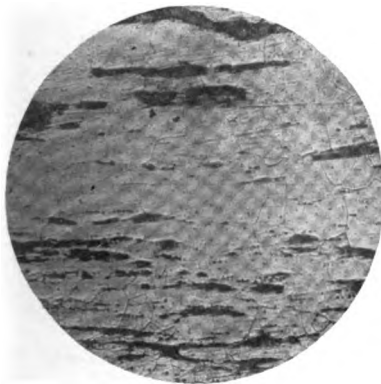
No. 27-A

Nos. 27-A and B—Byers pipe, installed in heating system in Eden Musee, New York City, 1885. Removed in 1918, in excellent condition. Good general structure, free from carbon.

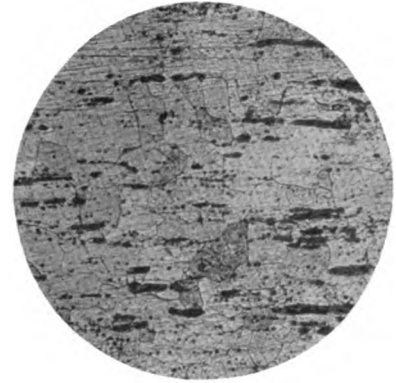
No. 29-B

Nos. 29-A and B—Morris Tasker & Co., pipe installed in 1872 in return line of steam heating system. Removed in 1907; corrosion very slight. Normal structure and slag quantity, entirely in keeping with present standards as maintained by Byers.

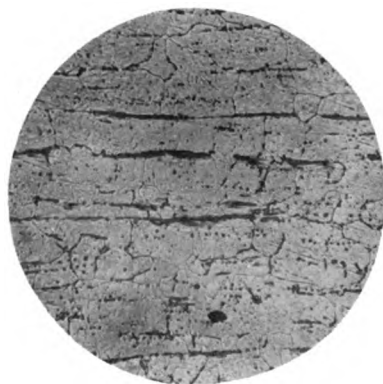
No. 30-C

Nos. 30-A, B and C—Byers pipe, installed at Duquesne Garden, Pittsburgh, in 1900. Very good general structure, with some zones carrying small amount of carbon; also a few large slag streaks.

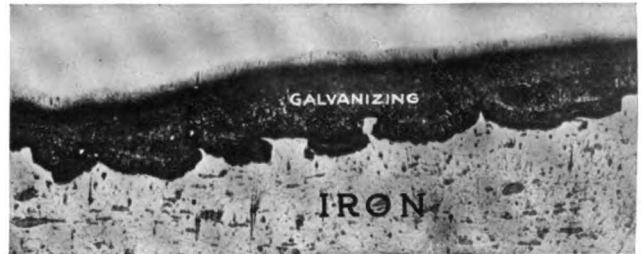
Fig. 60

The result is graphically illustrated in Figs. 60 and 61, which are micro-sections of wrought iron and steel pipe respectively, both galvanized, exhibiting the surface formation of both metals underneath the coating.

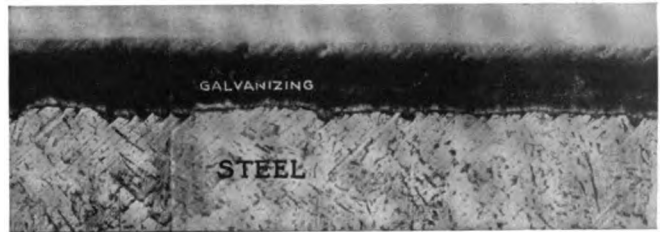
Fig. 61

Micro section of galvanized steel pipe. Note the characteristic smooth surface of the steel base, on which the zinc obtains but a poor anchorage, flaking off easily.

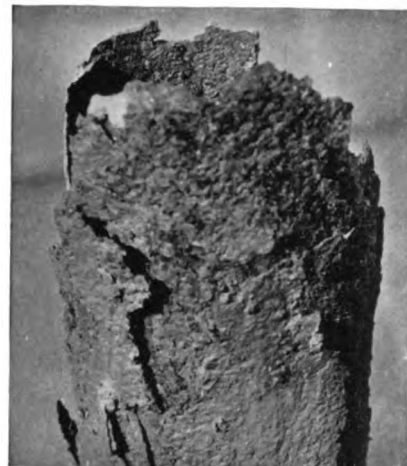
Fig. 65—Steel, Showing Aggravated but Typical Corrosion Resulting in Flaking or Scaling

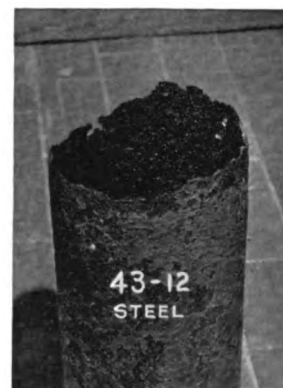
Fig. 66

WROUGHT IRON AND STEEL VENTS AFTER 24 YEARS' SERVICE IN THE LANGDON BUILDING

Vent and drainage piping usually compose the largest single part of a plumbing installation in respect to quantity of pipe used. In 1918, independent investigations were made in New York and Chicago of the relative life of cast iron, wrought iron, and steel pipe in house drainage systems, the older business buildings being selected for inspection. In this investigation, advantage was taken of the fact that waste and vent pipes extend through the roof where their interior is readily accessible for inspection. Accepting as indisputable evidence the visible condition of these roof terminals, the findings arrived at by independent investigators in Chicago and New York were in complete agreement as to the much longer life of wrought iron pipe. Figs. 64 and 65 are typical, though extreme, examples of the conditions of pipes after years of service in New York. In some buildings both wrought iron and steel pipe had been used without distinction. Figs. 66, 67 and 68 furnish eloquent illustrations of the relative corrosion of wrought iron and steel vent pipe in such buildings (Langson Building and Bowling Green Building, New York).

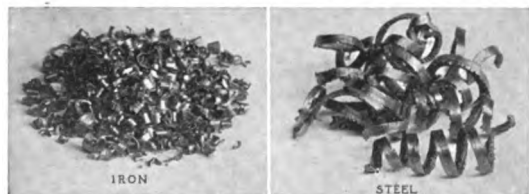
When wrought iron pipe is threaded, its fibrous structure causes the chip to *break and crumble* as when dressing the end of a piece of wood. (This prevents clogging of the die space and reduces friction. A clean, accurate thread results.)

With steel, owing to the absence of fiber, the chip tends to curl up, forming a *long, more or less perfect spiral*, beautiful to look at but an obstacle to easy threading, for it increases friction and causes clogging of the chip space.

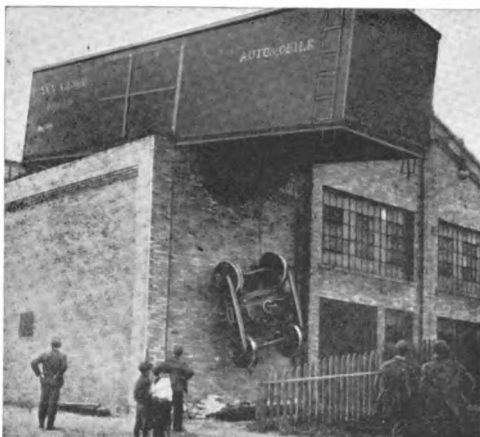
At North Rochester, Pa., a freight car recently ran off an elevated siding and lodged on factory roof as shown in picture. The front truck was torn loose but stopped in mid-air, suspended by the *genuine wrought iron* brake rod, only $\frac{3}{4}$ in. in diameter; a striking illustration of the toughness and strength of genuine wrought iron. (Compare with statement of Wallace G. Imhoff, Consulting Engineer, page 4.)

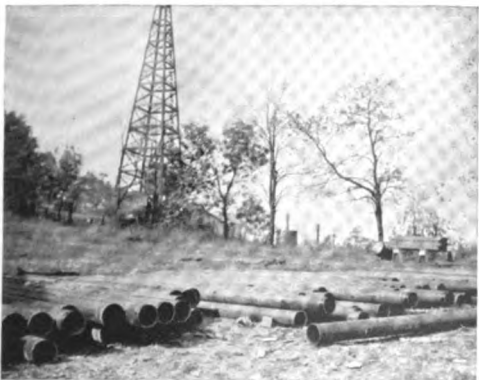
Byers genuine wrought iron casing, after eight years' exposure to the elements, on property of Donaldson Bros., Langloth, Pa. The pipe still looks like new and the threads are clean and perfect.

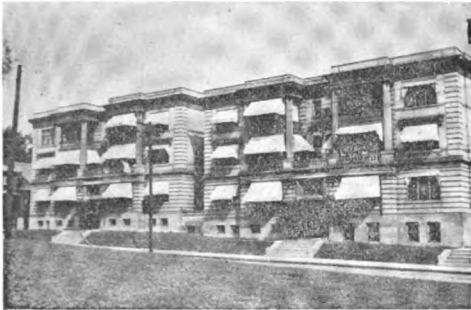
Lafayette and Cambridge Apartments, McKee Place, Pittsburgh, Pa., erected 1902. Wrought iron pipe in hot water mains had a life of 14 years in these apartments—twice the average life of steel pipe in the same service. Byers Bulletin No. 30, containing the results of an investigation conducted to determine the relative life of iron and steel pipe in hot and cold water lines in buildings, will be sent on request.

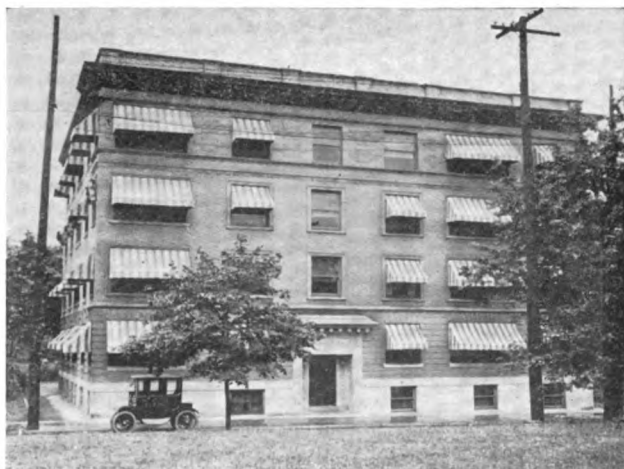
D'Arlington Apartments, erected 1909, equipped with brass pipe. The hot water lines are badly corroded and pitted after 8 years' service. Record No. 7, Brass Installations, page 13.

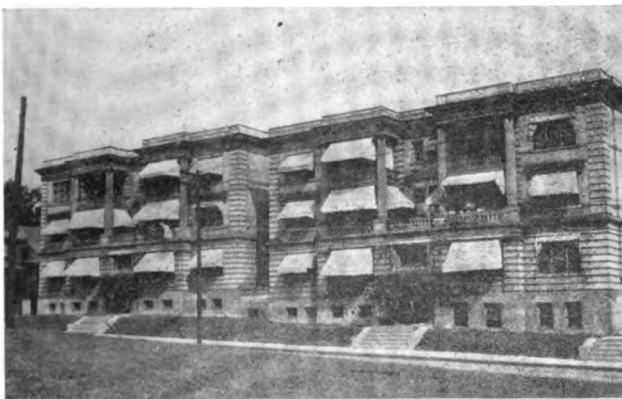
Lafayette and Cambridge Apartments, McKee Place, erected 1902, equipped with wrought iron pipe. Most of the hot water mains were replaced in 1917, after 14 years' service. Record No. 42, Wrought Iron Installations, page 17.

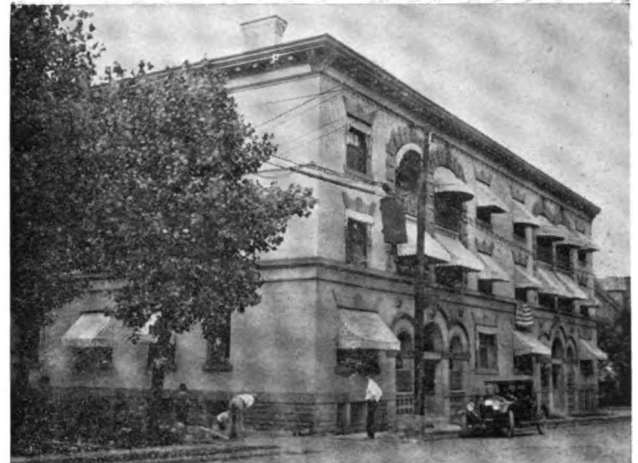
The Howe and Kent Apartments, erected 1907. The hot water mains are of brass and already show pitting. See records on brass piping, page 14.

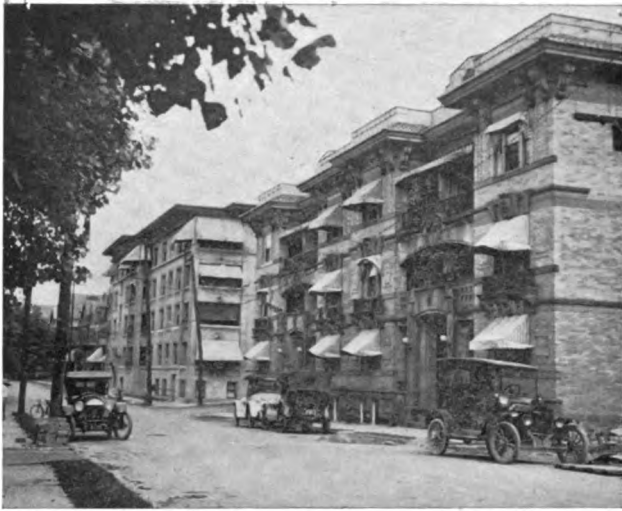
St. Regis, Chesapeake, and Chamberlin Apartments, erected 1908. Equipped with steel pipe. Most of the hot water mains have already been replaced. See records Nos. 17, 18 and 19, page 15.

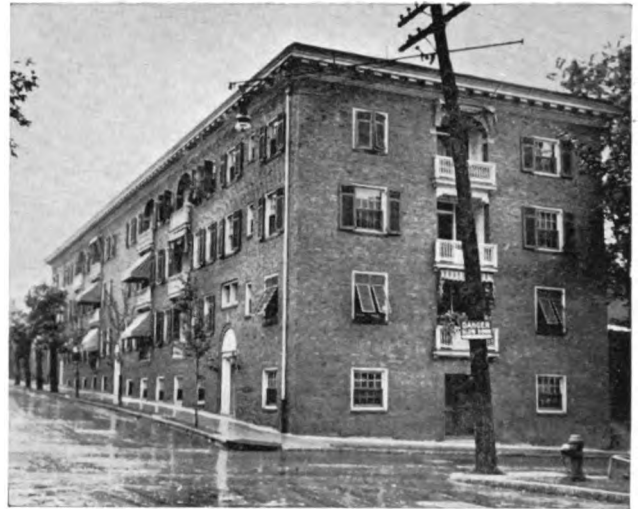
Negley Apartments, erected 1909. Hot water mains of steel, largely replaced between 1911 and 1914. Trouble with rusty water. See record No. 1, page 15.

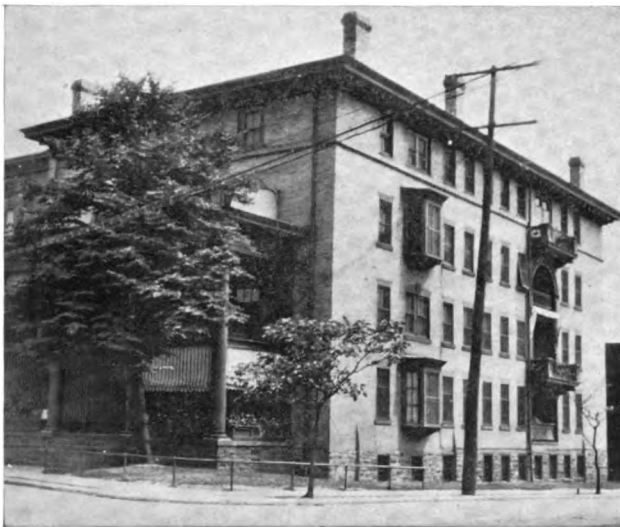
Kennett Apartments, erected 1902, equipped with brass pipe. Record No. 4, page 13. Typical of most apartments equipped with brass pipe, the hot water mains being badly corroded after 10 to 15 years' service.

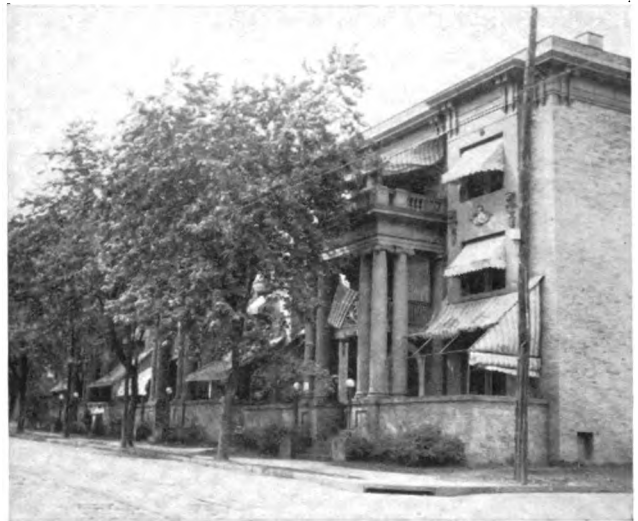
The Lexington, Argyle, and Drexel Apartments, erected 1909. Equipped with steel pipe. Life of hot water mains, 7 or 8 years. See records Nos. 13, 14 and 15, page 15.

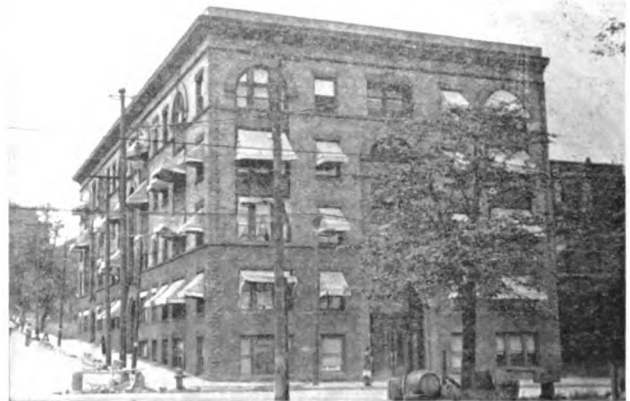
Oakland Apartments, Halket and Forbes Streets, erected in 1902, and equipped with wrought iron pipe, all of which is still in good condition, excepting the hot water mains which now need replacement after 15 years' service. See record No. 55, Wrought Iron Installations, page 18.

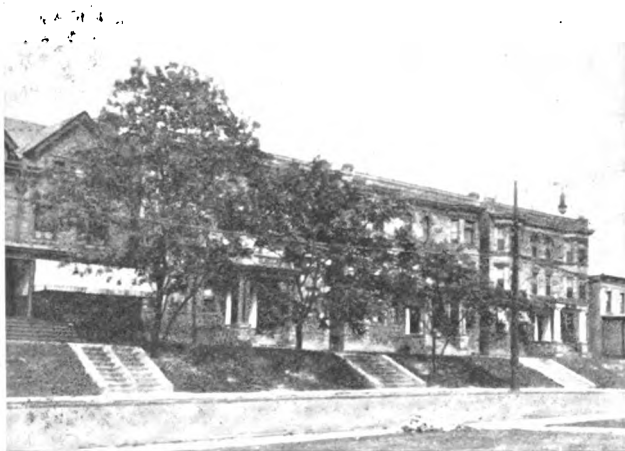
Yellow Brick Apartments, erected 1902. Equipped with wrought iron pipe. Hot water mains needing replacement after 14 years' service, See records Nos. 43 and 44, page 17.

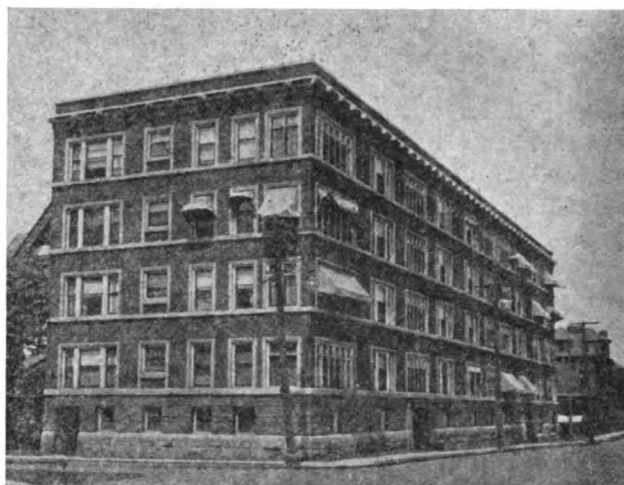
The Netherlands Apartments, Summerlea and Elwood, erected 1911, equipped with steel pipe. The hot water soon became so rusty that filters were installed in 1916. These filters, however, have not eliminated the rust from the water. See record No. 20 on page 15 and also paragraph on "Rusty Water" on page 7.

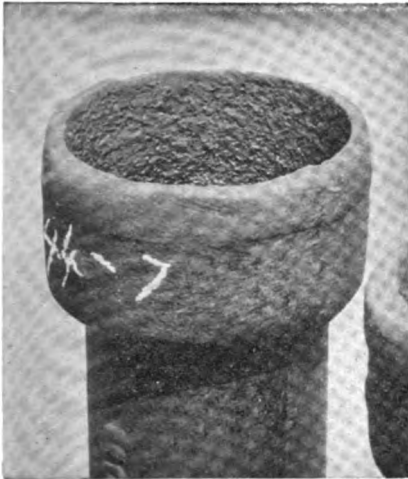
Fig. 2—Cast Iron. Showing Typical Corrosion Resulting in Even Pock-marking or Shallow Pitting.

used on the diagrams or elsewhere in this paper, it should be understood that it does not indicate irregular, deep pits, such as are so frequently found in hot water pipes, and which in a comparatively short time may result in complete perforation of the metal. (See Figs. 2 and 3.)

Extra heavy cast iron soil pipe, on the other hand, was found in a number of buildings, and in nearly all cases the cast iron vents were found to be evenly pitted on the inside, similar to wrought iron vents, and still good for many years' service. (See Fig. 2.) In one building, two cast iron roof pipes were found with large holes; these were, undoubtedly, pipes with sand or blow holes, which were originally defective, and the other cast iron vents on the same roof were found to be in good condition, although pitted. In one or two instances cast iron vent pipes were found to be as good as new, though they were the original pipes put in when the building was erected, in one case 36 years ago; in another case over 35 years; in another 29 years ago. In the case of one building with a cast iron system, erected 30 years ago, the roof vents were in good condition, but showed the characteristic pitting and were partly choked up at the bends with rust and dirt.

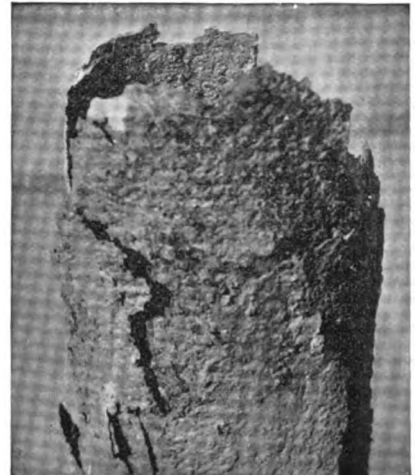
Fig. 4—Steel, Showing Aggravated but Typical Corrosion Resulting in Flaking or Scaling.

Just how surprisingly bad this condition was, is but poorly indicated by the photographs which accompany this paper, for a pipe which might look fairly good with a thin crust of flaky material, would, when the flakes were removed, frequently turn out to be so thin as to be incapable of supporting its own weight. (See Fig. 4.)

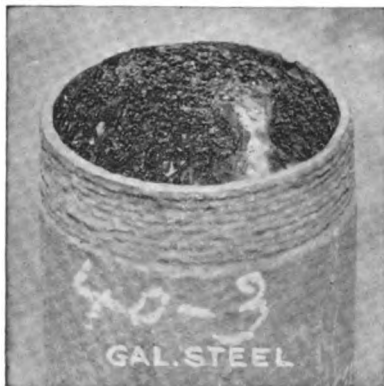
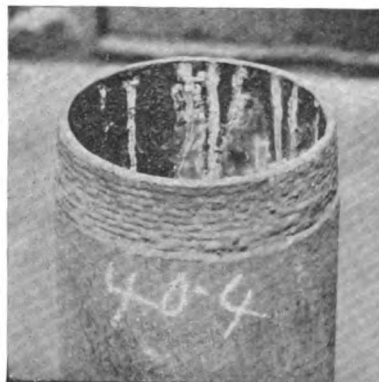
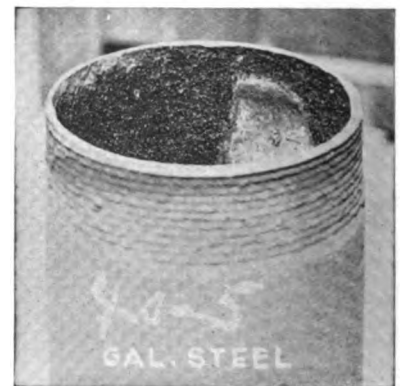
Three Galvanized Steel Vents, 19 Years Old in the Broadway-Chambers Building.

No. 40-3, No. 40-4 and No. 40-5 (Figs. 9 to 11) represent galvanized steel vents on the roof of the Broadway-Chambers Building which are 19 years old; the galvanizing has nearly disappeared in this time, leaving the base metal open to attack. These three vents are typical illustrations of the *best* galvanized steel vents to be found in buildings of the same character and age.

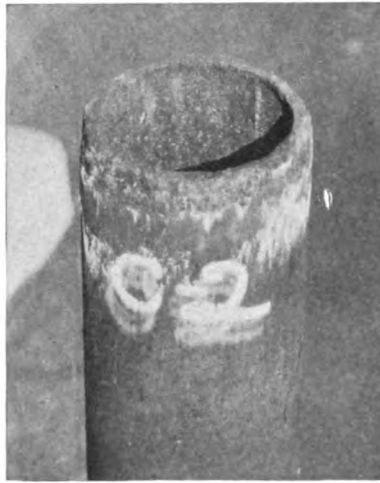
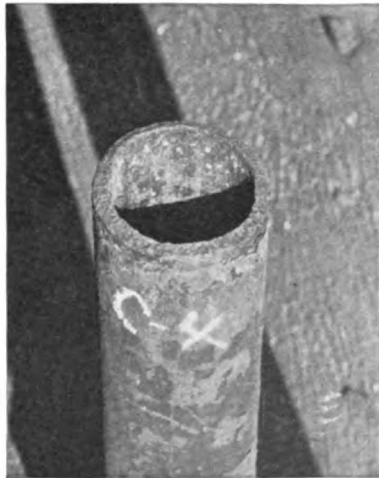
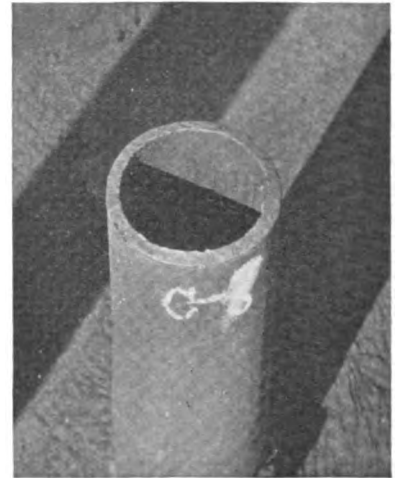
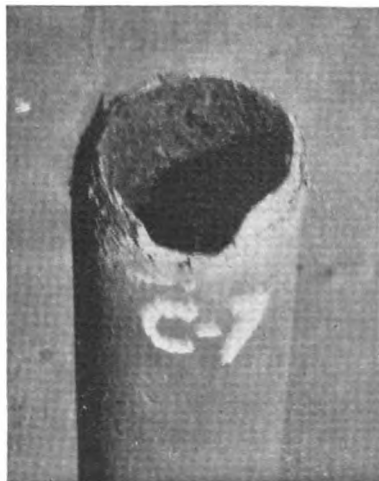
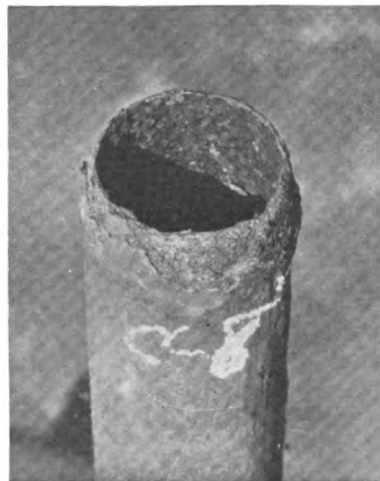
35 YEARS' SERVICE

**BLACK WROUGHT IRON
VENTS IN THE COUN-
SELMAN BUILDING**

Erected 1883.

The vents on this building—8 in all—are black wrought iron, in an excellent state of preservation, in spite of 35 years' service. As the lead coping is absent, the condition of each vent is clearly shown. Nos. 7 and 8 are corroded at the top but good inside.

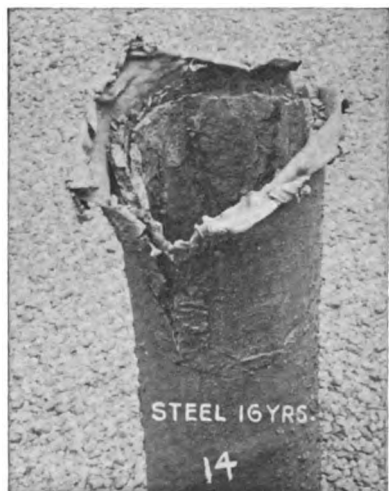
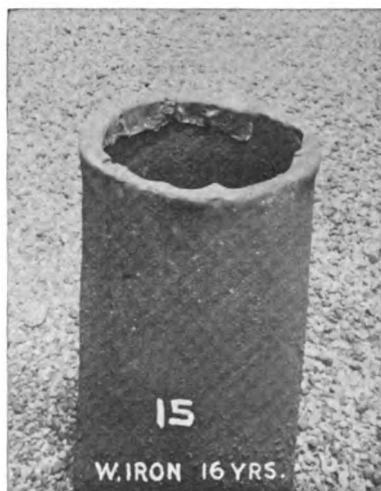
Plate No. 3—NATIONAL LIFE BUILDING, ERECTED 1902, CHICAGO.

Wrought Iron and Steel in Same Service

Nos. 14 and 16 are typical of the steel vents on this building, which are from 50 to 75 per cent destroyed. No. 15 shows iron vent on same roof, corroded, but only to a small extent.

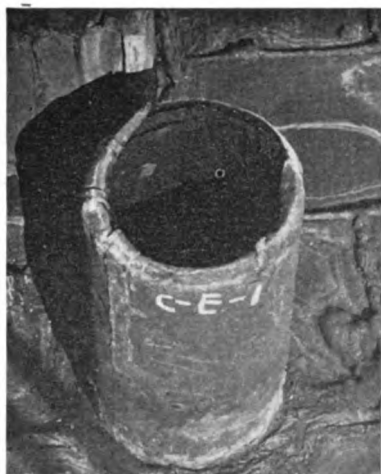
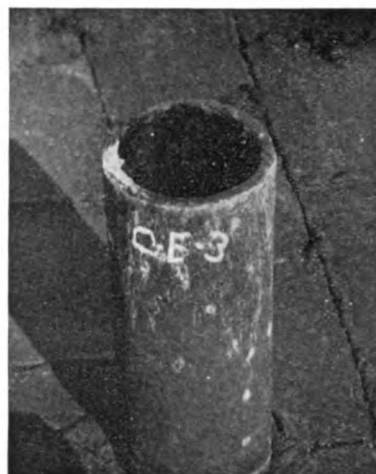
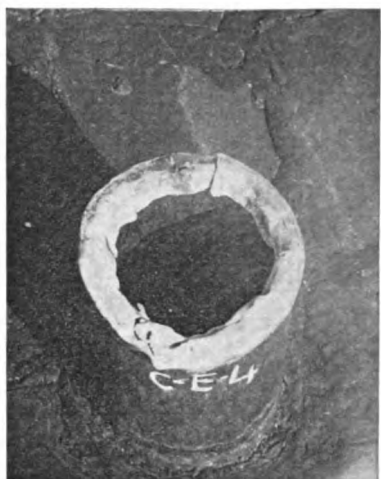
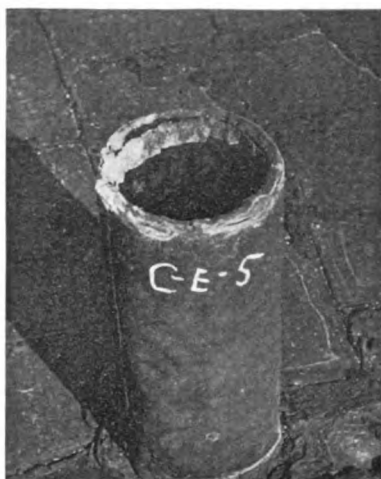
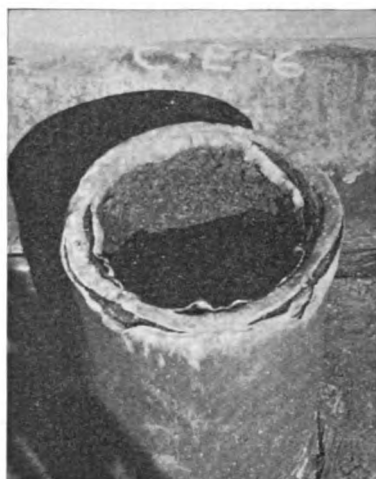
PLATE No. 8

**STEEL PIPE, INSTALLED 1908 IN THE
CORN EXCHANGE BANK BUILDING,
CHICAGO, ILLINOIS.**

- No. 1—Scaling badly.
- No. 2—Almost destroyed, only thin shell remaining.
- No. 3—About 25% destroyed.
- No. 4—Almost destroyed, only thin shell remaining.
- Nos. 5 and 7—About 25% destroyed.
- No. 6—About 50% destroyed.

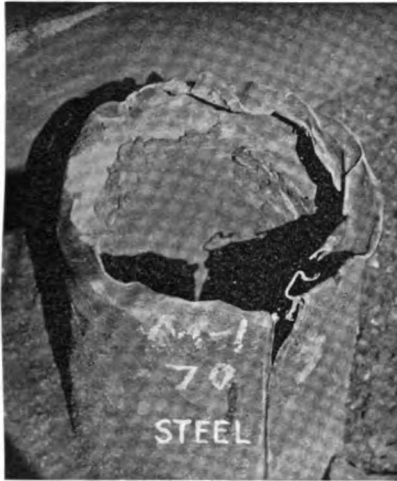
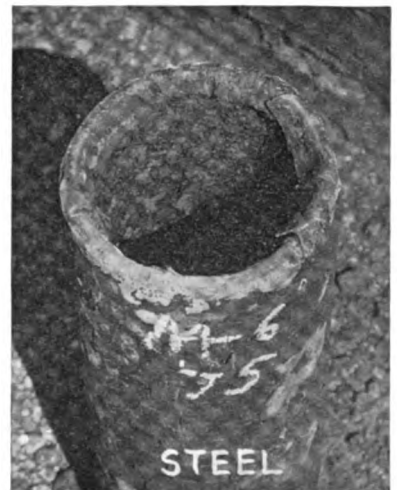
PLATE No. 9

**WROUGHT IRON AND STEEL PIPE, INSTALLED
1894—MARQUETTE BUILDING, CHICAGO.**

- Nos. 1 and 2—Nearly destroyed (steel b.)
- Nos. 3 and 4—Pitted but in good condition
(wrought iron b.)
- Nos. 5 and 7—Scaling badly, from 50 to 80 per cent
destroyed (steel b.)
- No. 6—Scaling badly (steel b.)

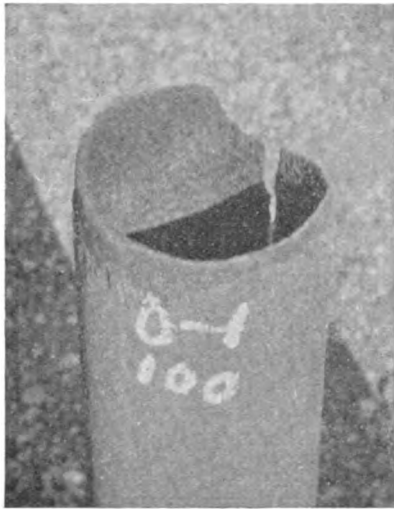
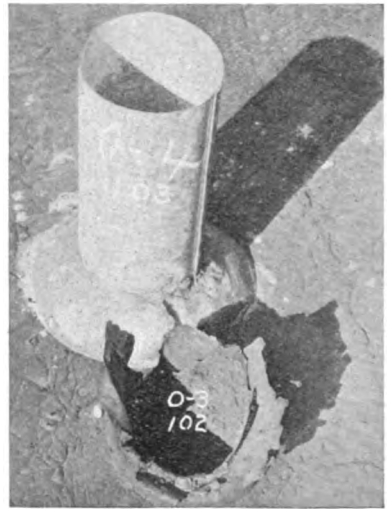
PLATE No. 11

**CAST IRON, INSTALLED IN 1892
OXFORD BUILDING, CHICAGO.**

The photos give a good idea of the destruction of the cast iron vents after 26 years' service.

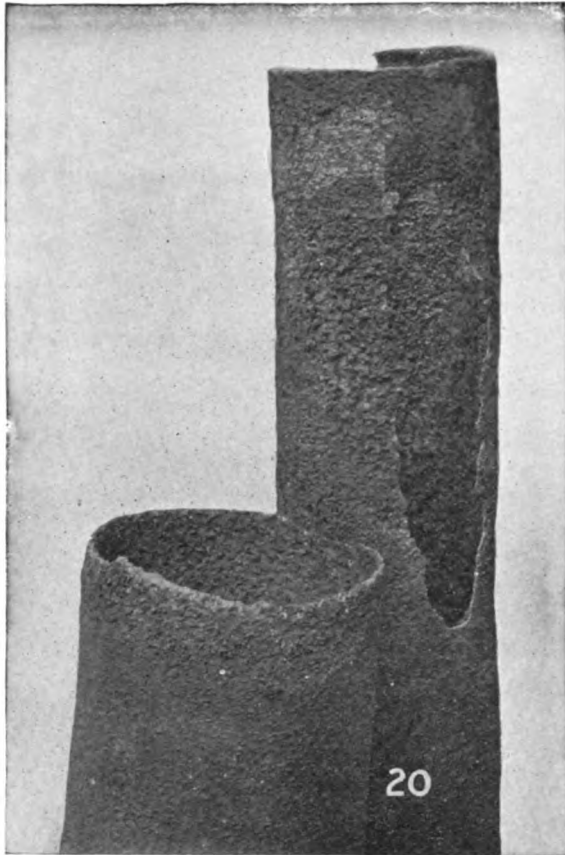
Plate No. 12

CAST IRON VENTS

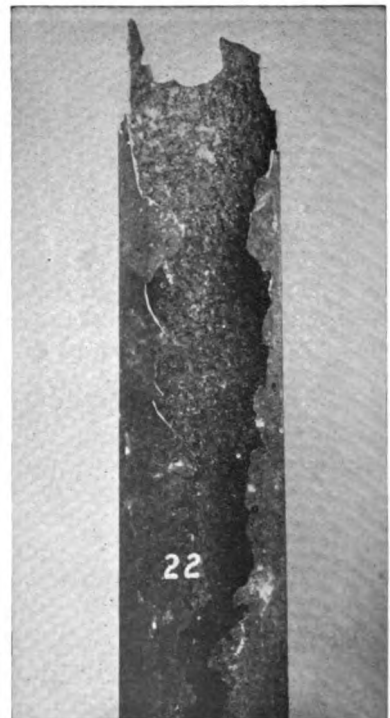
4-in. standard cast iron, just above the top tee in bath room. Supposed to have been installed in 1875. Completely destroyed by corrosion.

NOTE:—These installations illustrate that cast iron is far from being immune to corrosion, even though it usually gives very satisfactory service from a corrosion standpoint.

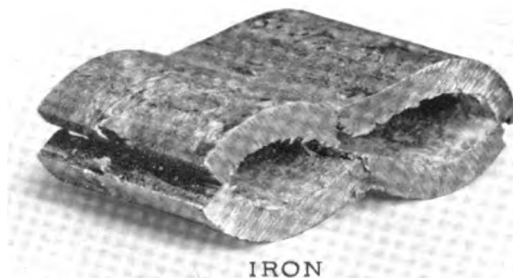
FIG. 4. GALVANIZED IRON PIPE
Take a short piece of pipe and flatten it out. If it is iron, the galvanizing will stick like glue—it may break, but it will rarely scale off. The rough surface of genuine wrought iron affords excellent anchorage for zinc and other protective coatings.

This difference in the adhesive quality of a galvanized coating on pipe is readily demonstrated by taking two rings or short pieces of pipe and flattening them in a vise or by hammering, as shown in Figs. 3 and 4. If the pipe is steel, the coating will flake off much more readily than when it is wrought iron. Incidentally, the wrought iron, due to its fiber, will fracture lengthwise under this test, as shown in Fig. 5, while steel may be hammered flat on itself without fracture. This is, therefore, a good method of finding out, first, if a given piece of pipe is wrought iron or steel; second, for demonstrating the

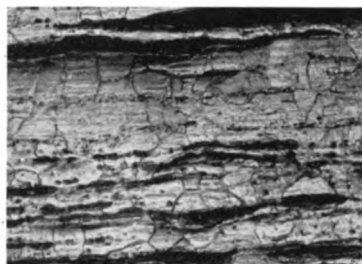
Figure 13—Micro section of wrought iron taken parallel to rolling. The black streaks are non-corrosive slag.

Polish pipe to be tested, as customary in the preparation of metallographic samples, and etch with picric acid. The metal, if genuine wrought iron, will show the characteristic silicate slag fibers in the longitudinal section (parallel to rolling) and ends of slag fibers in a cross section of metal. If steel, no such slag fibers will be present, but an even distribution of pearlite, consisting of one part of combined carbon and six parts of iron. See Figures 12, 13 and 14.
