# Rebuilding Fifth St. Bridge at Augusta, Ga.

Plate-girder spans designed as cantilevers replace old through trusses over Savannah River

By Searcy B. Slack

Bridge Engineer,  
State Highway Board of Georgia, Atlanta, Ga.

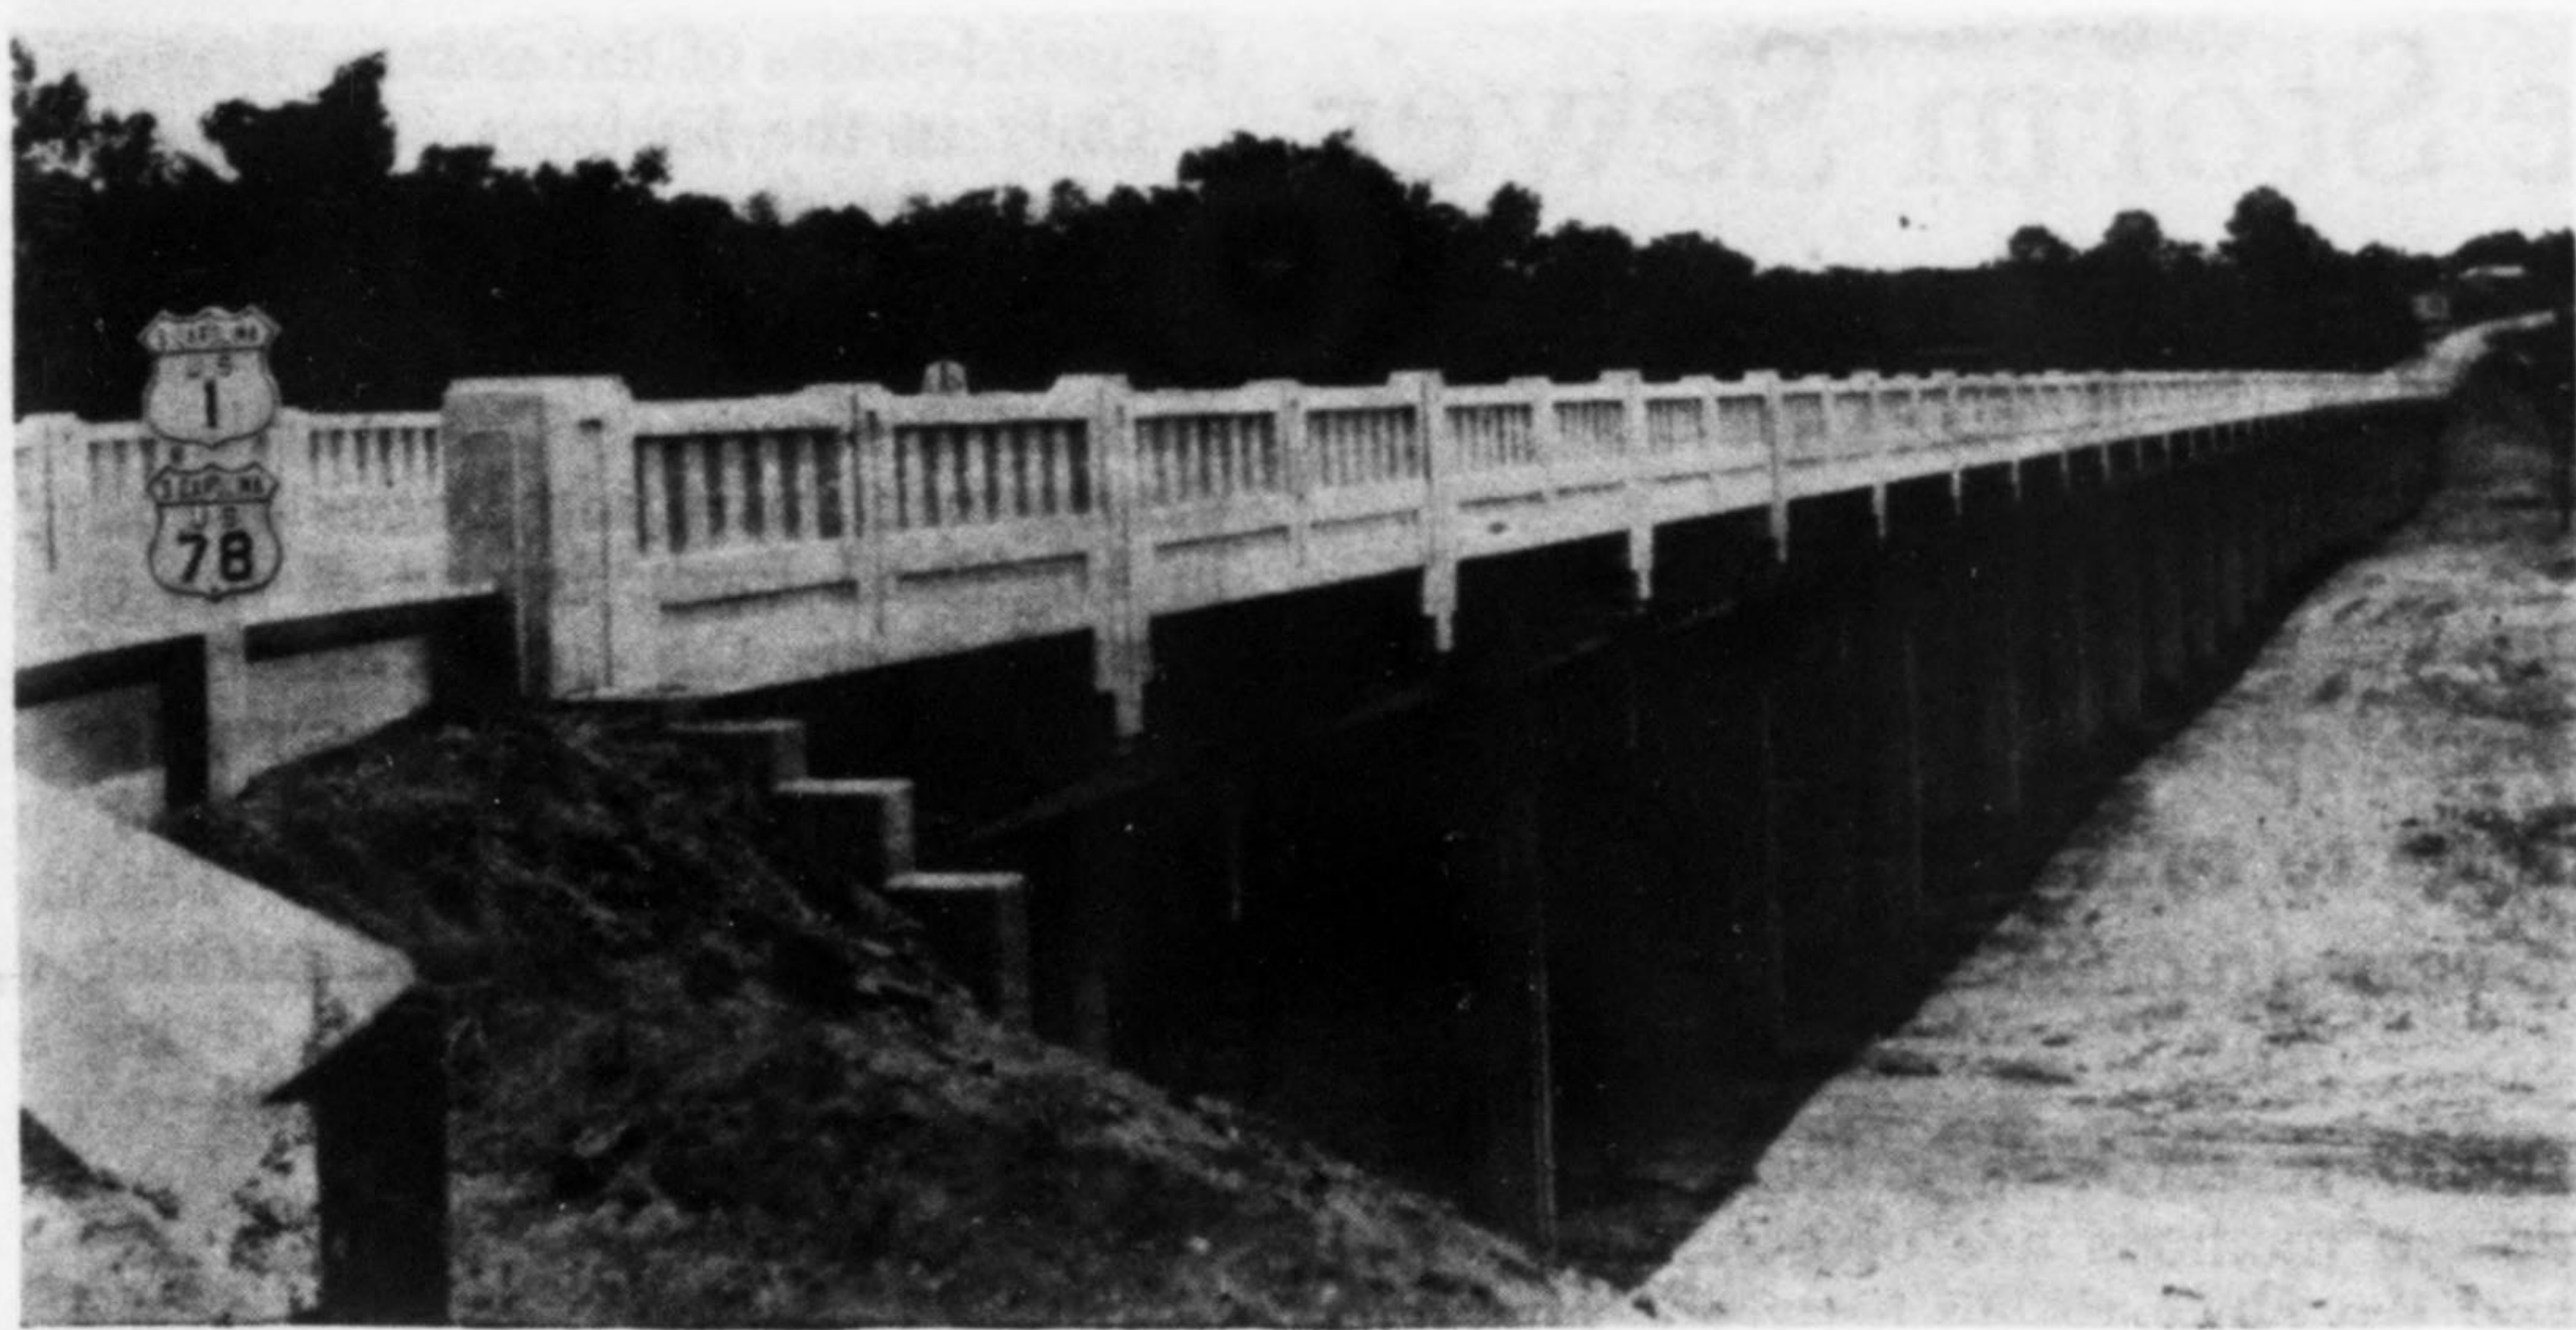
Fig. 4—Relief bridge of concrete deck girders that replaced 1,200 ft. of fill in approach to Fifth St. bridge, Augusta, Ga.

Also in the new project 1,200 ft. of the approach fill is replaced by a flood-relief bridge of concrete deck girders.

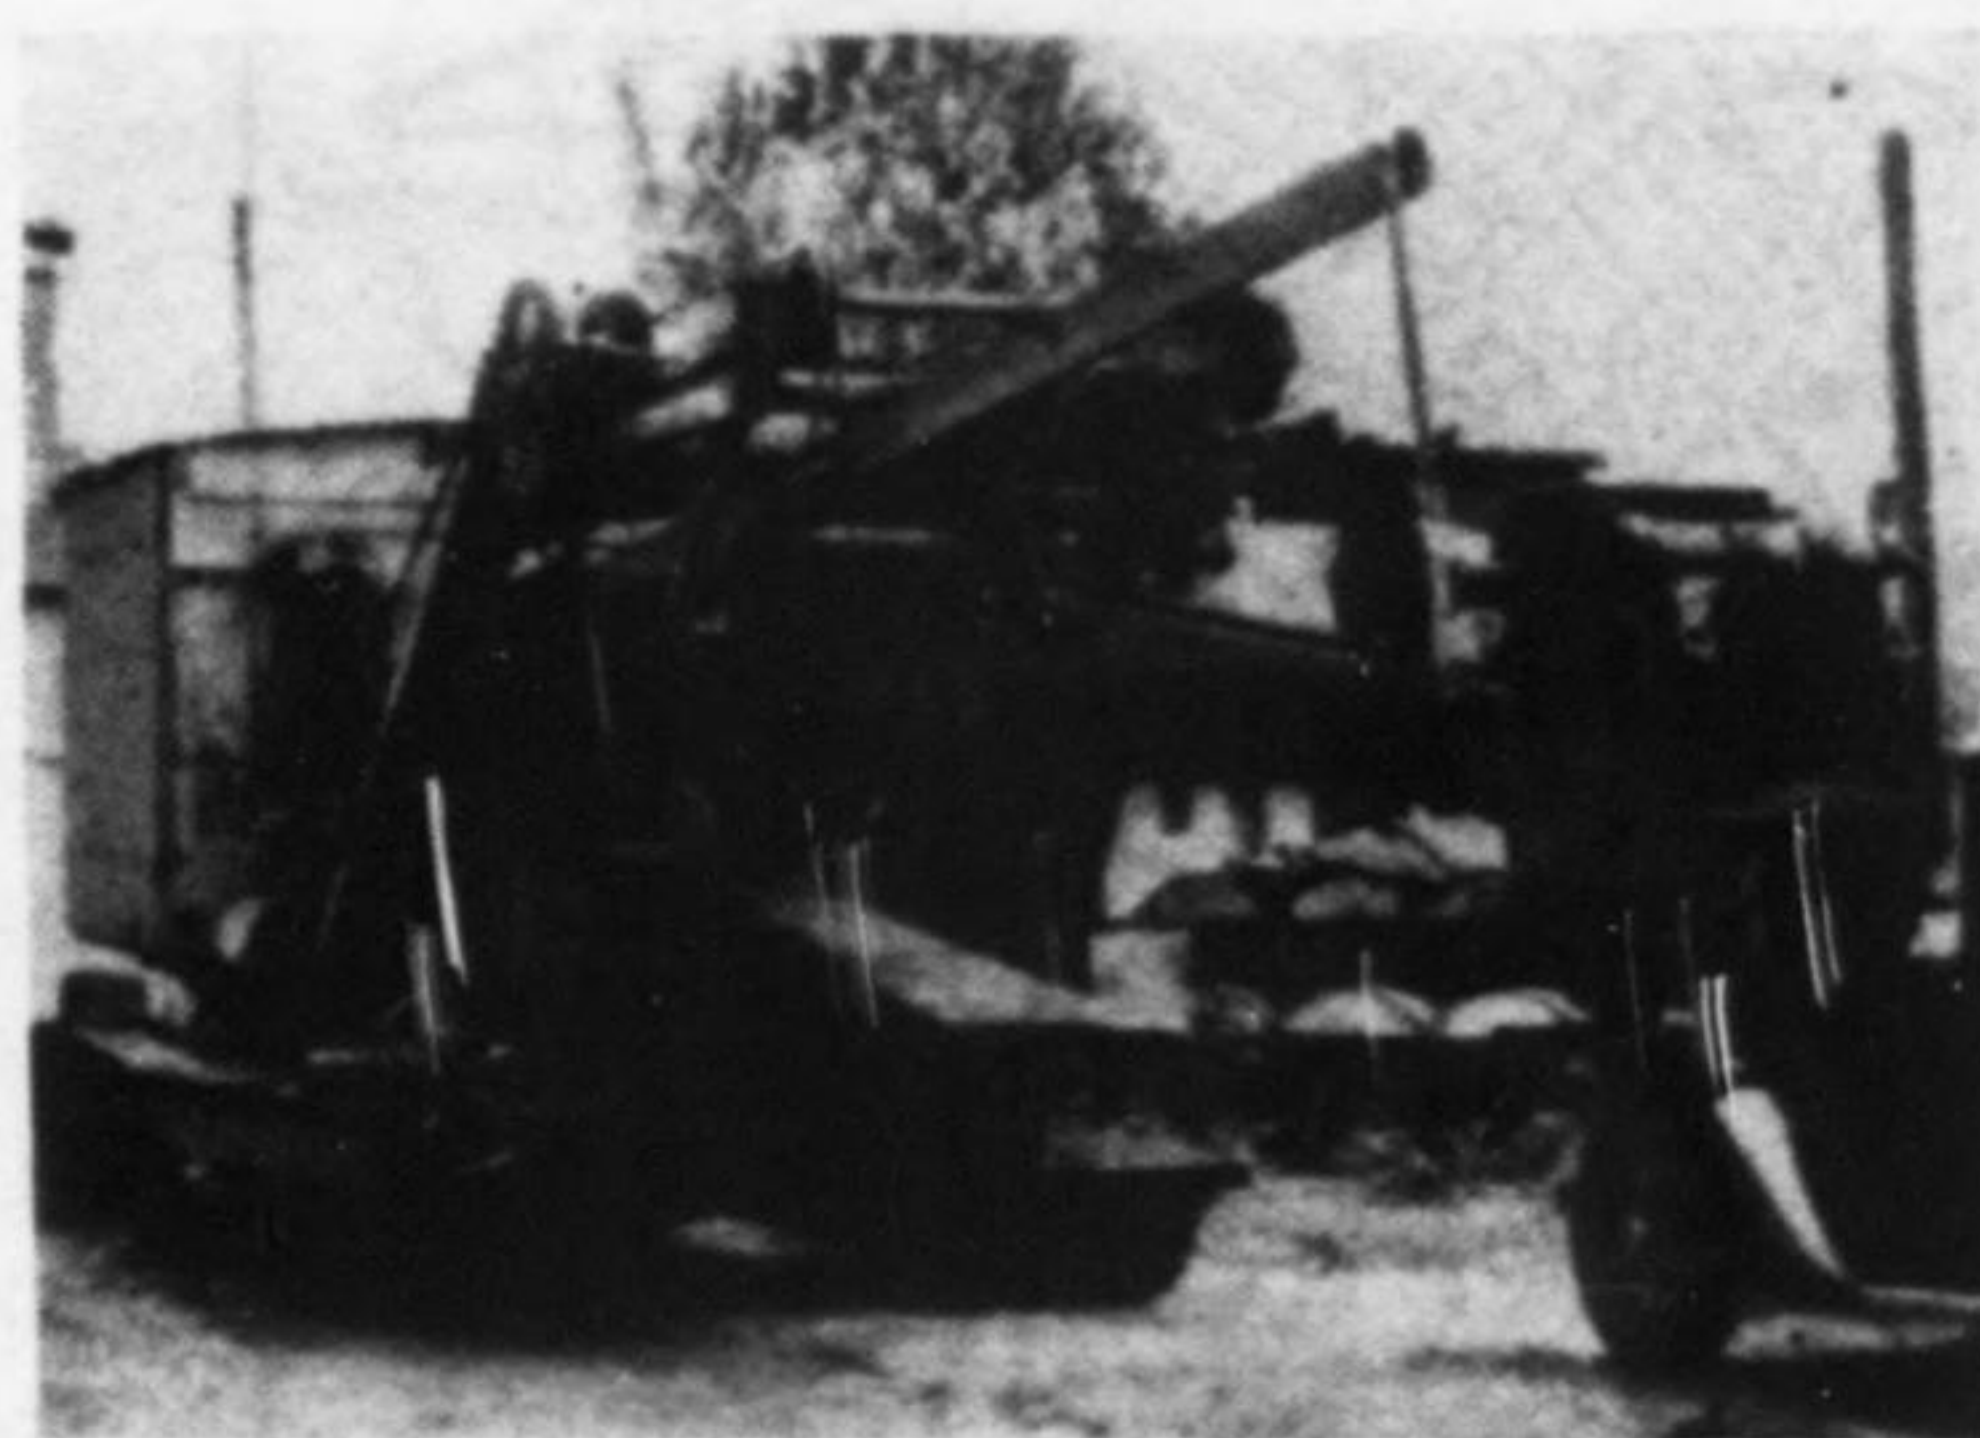
Ladder-type trench excavator employed on 28-mile water main from Lincoln to Ashland, Neb.

distance of 28 miles. This ditch is 5 ft. wide and from 6½ to 18 ft. deep. The trenching machines employed for this work, as shown in the accompanying illustration, are of the boom type, so that the digging teeth strike the earth in a horizontal position. Each set of cutters consists of 105 to 120 teeth, costing 60c. each. After the teeth be-
