Rehabilitation, Repair, and Reconstruction of the Walnut Street Bridge Hellertown, PA

Rehabilitation of a Nineteenth Century Cast and Wrought Iron Bridge

- ❑ **Location:** Formerly crossing Saucon Creek on Walnut Street, Hellertown, Northampton County, PA
- ❑ **Date Built:** circa 1860; Original location unknown
- ❑ **Fabricator:** Charles N. Beckel, Beckel Iron Foundry and Machine Shop, Sand Island, Bethlehem, PA
- ❑ **Owner:** Hellertown Historical Society
- ❑ **Significance:** Only extant high-truss span built by Beckel; Uses Francis C. Lowthorp's June 30, 1857 patented lower chord cast connection; Floorbeams fabricated from cast iron

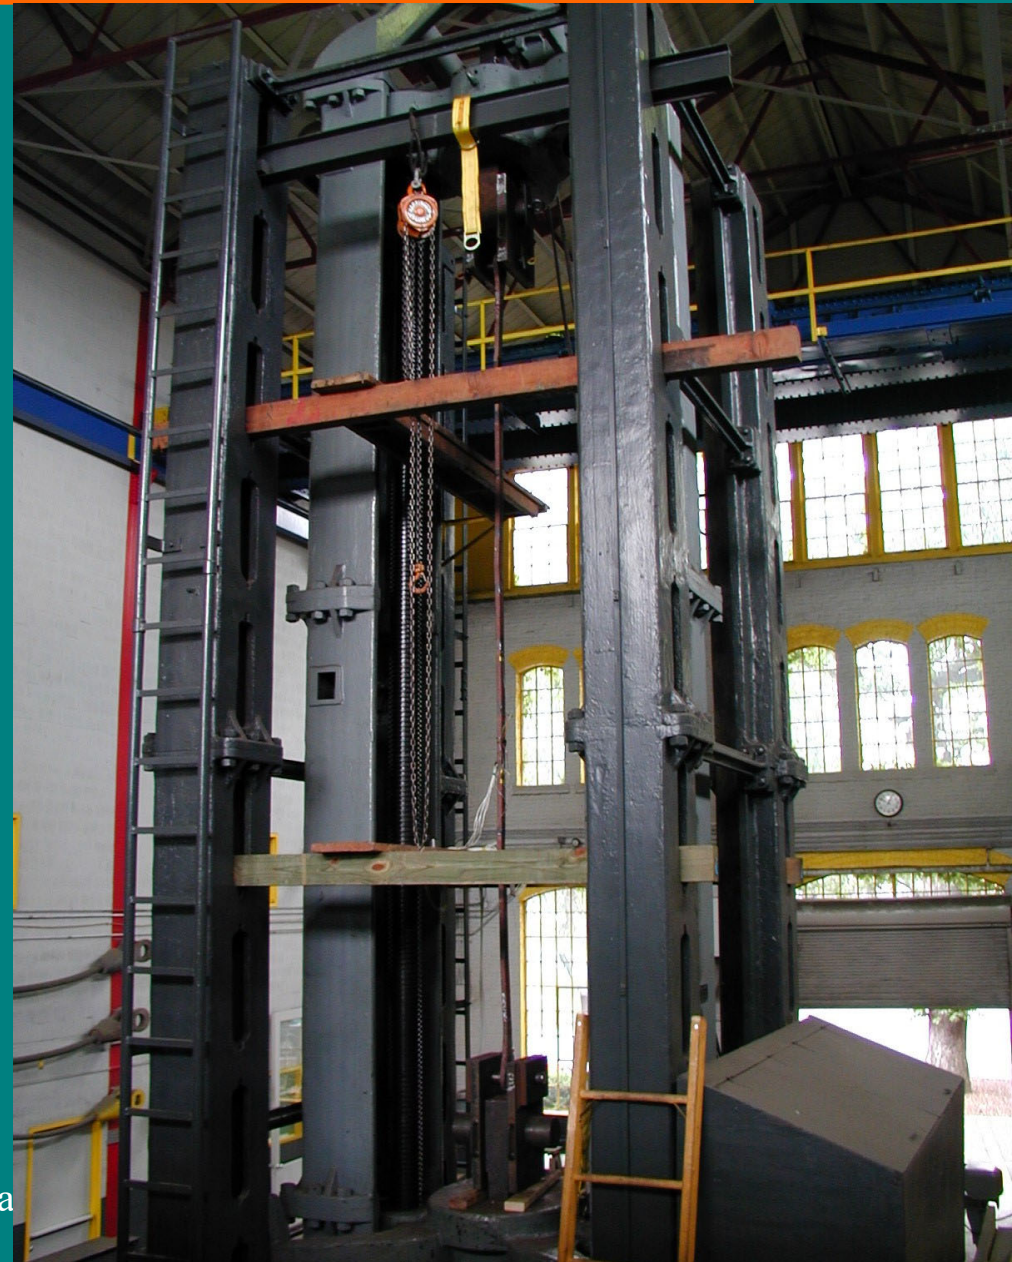
Full-length Eyebars Tests

- Tested as true pin-ended members in an 800 kip Riehle testing machine; Specimen gage length was ~170 inches
- Overall specimen elongation was measured with a string potentiometer; Local specimen strain data was collected by pairs of strain gages located at midheight and at 2 ft. below midheight; Load data was collected from a calibrated load cell attached to the balance arm of the testing machine
- Tests were conducted at an approximate constant displacement rate

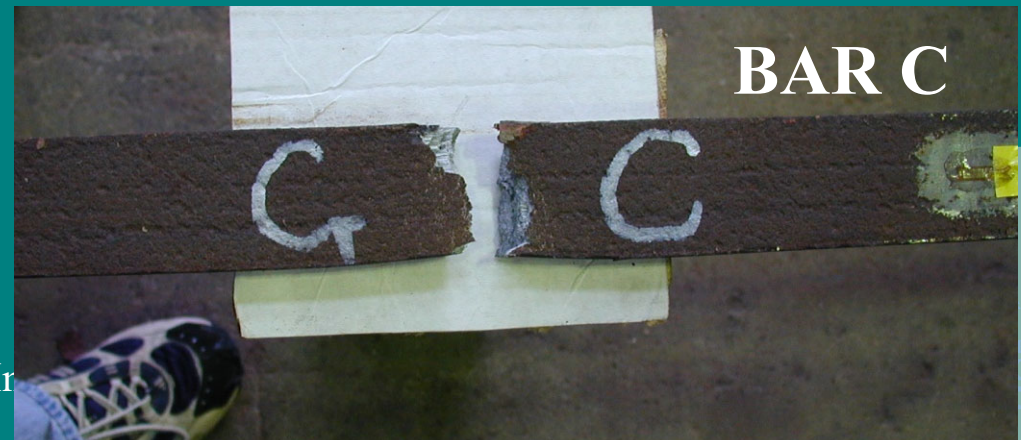
- Failed 0'-7" from mid-height
- 31% reduction in x-sect. area
- 13.3% incr. in overall length

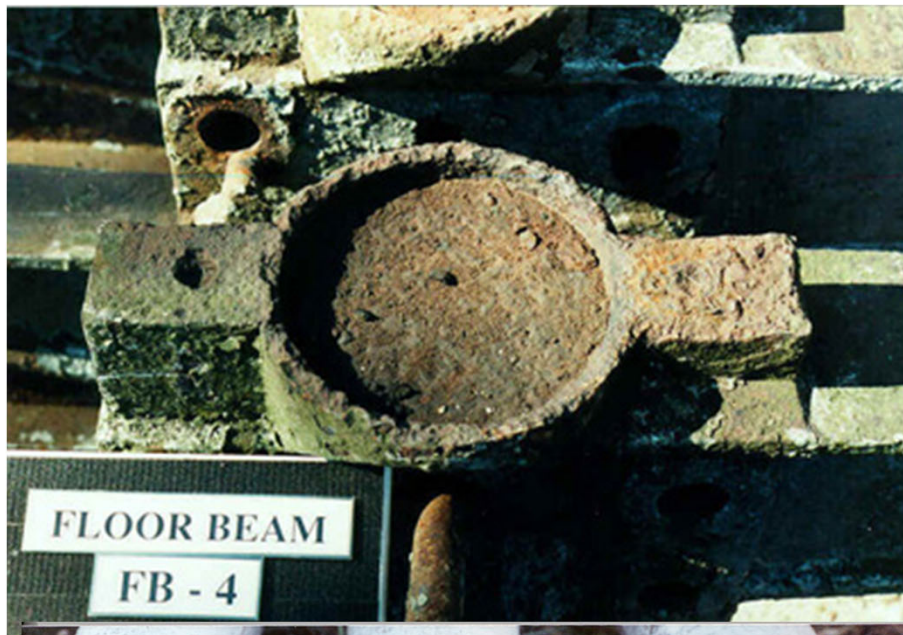
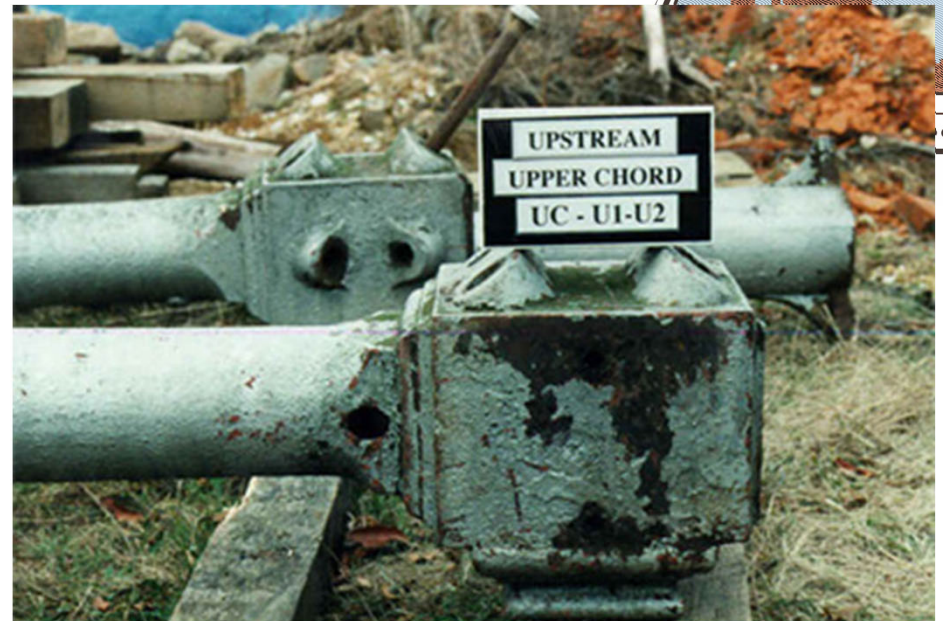
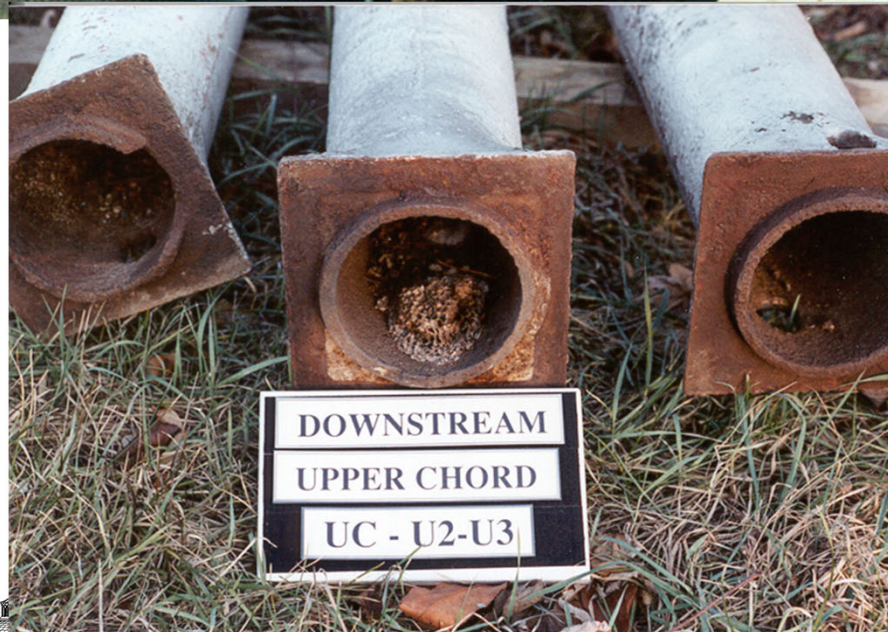
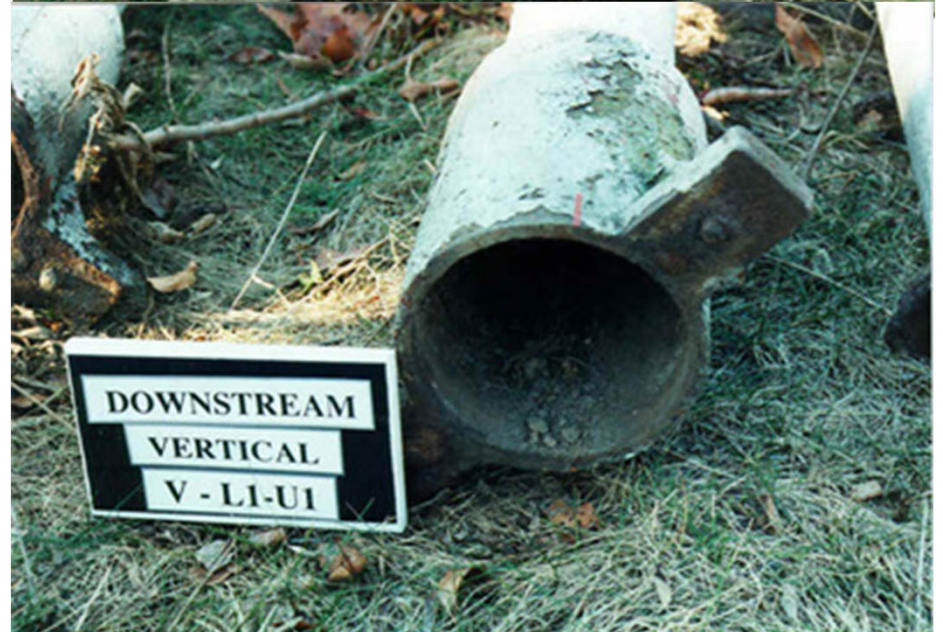
FALL 1994

Shortly after the bridge was disassembled and all the cast iron pieces moved to a secure area within the Historical Society's property a member by member condition assessment was undertaken. One can clearly see the amount of corrosion that has taken place at the vertical member-floorbeam connections, the amount of organic debris from bird's nests to wasp's nests found in the vertical column members, and the deterioration of the cast iron members especially at the joint interfaces where cast alignment collars have been slightly damaged to completely broken or sheared off.

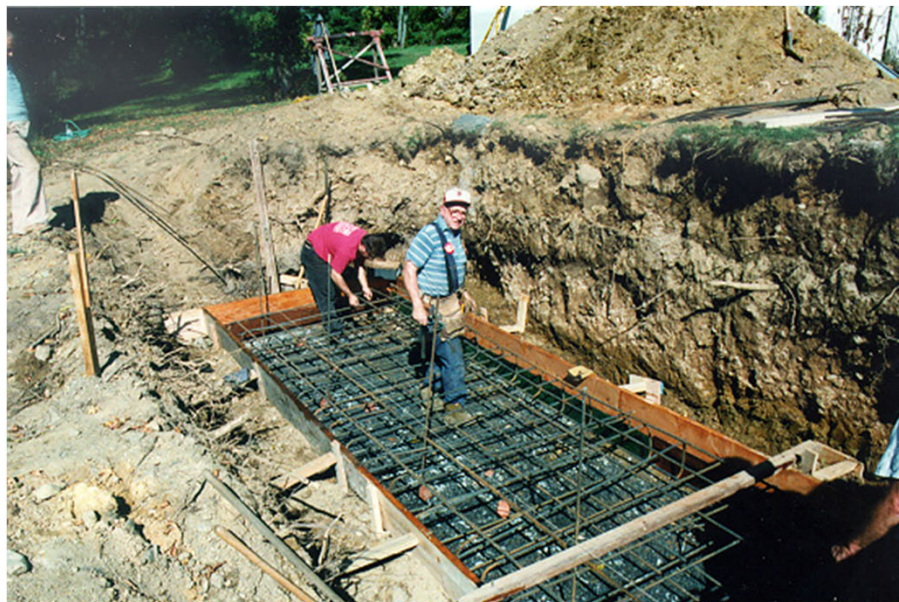
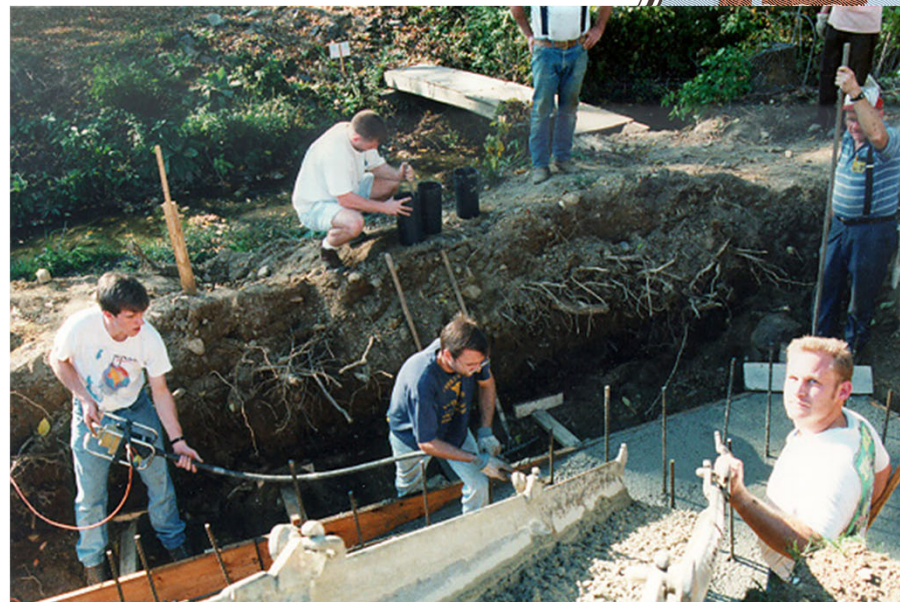
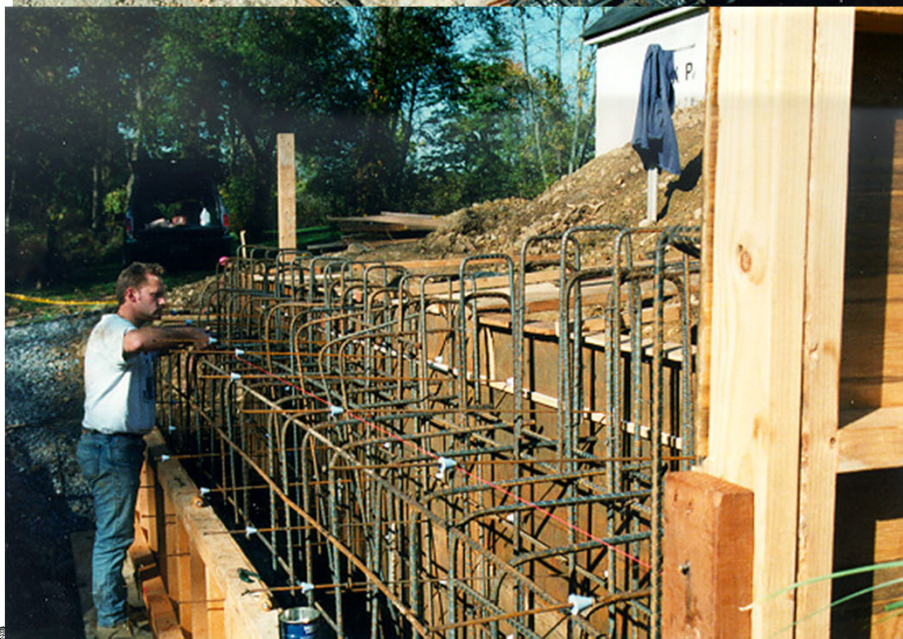
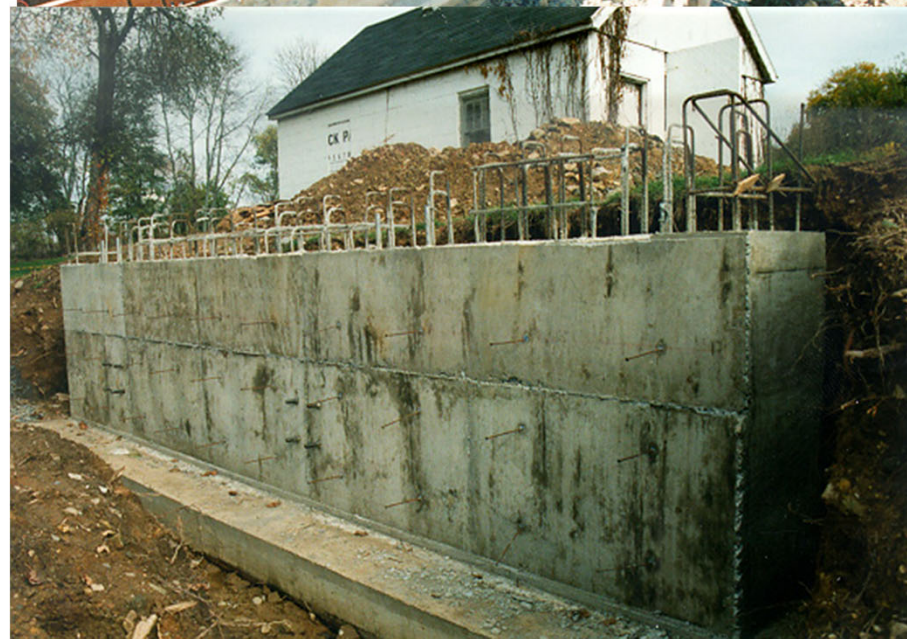
FALL 1995

Foundation and abutment wall design was completed during the Summer 1995 and in the Fall of that year two new bridge support structures were constructed.

All the labor utilized for this effort was volunteer, which included layout and bending of all the reinforcing bars, surveying the site for general location and detailed placement of the foundations and walls, constructing the formwork, tying the rebar cages, and placing the concrete.

During excavation of the west foundation and abutment wall the local water table was breached so a dewatering system had to be put in place. This minor complication was overcome with a little more effort and plenty of stone.
